Worth County

Community Lake

Ten Year Area Management Plan

FY 2015-2024

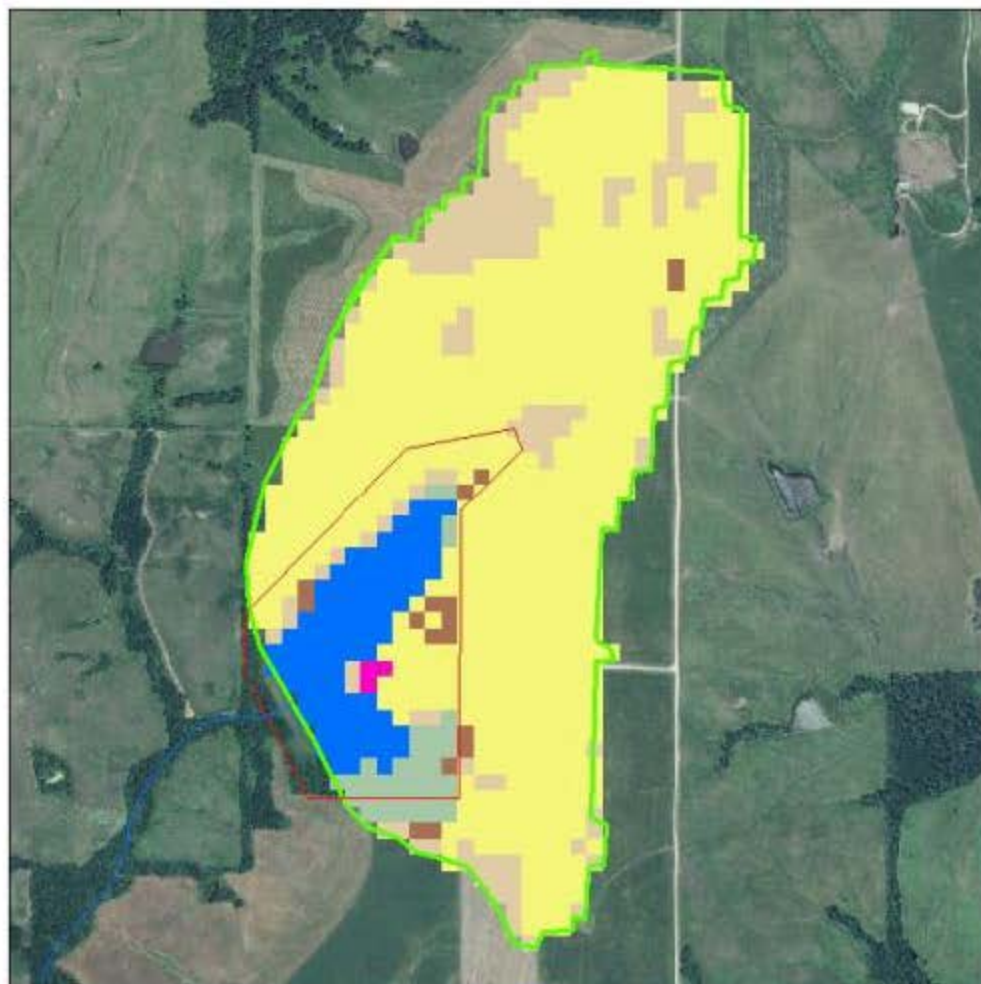
Figure 2: Land Uses in the Watershed

Lake = 20 acres
 Watershed = 293
 W:L = 15:1
 MDC Owns 19%

LULC_CODE1	PERCENT	ACRES
Impervious	0	0.67
Cropland	15	32.01
Grassland	71	156.05
Deciduous Forest	4	8
Deciduous Woody/Herbaceous	2	3.78
Open Water	9	20.23

- 1) The Missouri Department of Conservation (the Department) currently owns 19 percent of the 293 acres in the lake watershed (Figure 2).

- 2) Shallow depths in the upper arm of the lake and occasional algae blooms suggest sedimentation and nutrient inputs have been significant in the past. Although most of the watershed (71%) is currently grassland (cool-season pasture), untimely runoff of fertilizer or conversion of pasture to cropland could have negative impacts on the fishery.
